# Copter Service Leipzig

## Inspection Report

Asset: Gebäu-  
de 1

## Gebäude 1

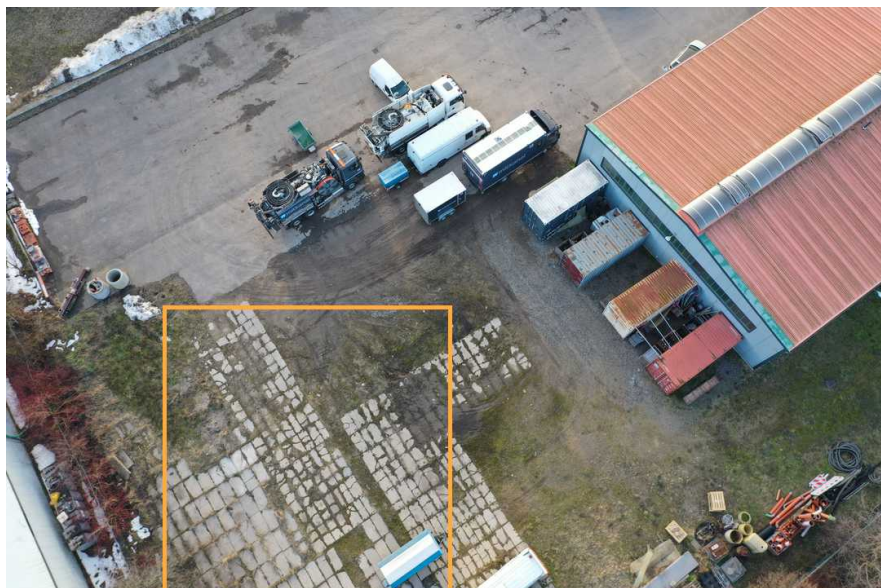
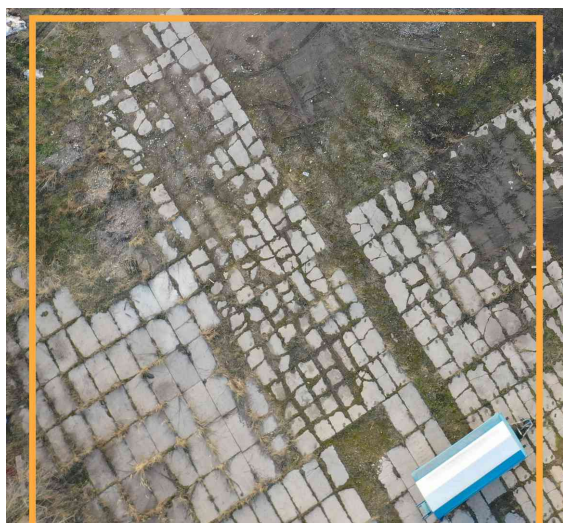
**Annotation 11**

**Severity level:** 4

**Description:** unbefetigte Fläche

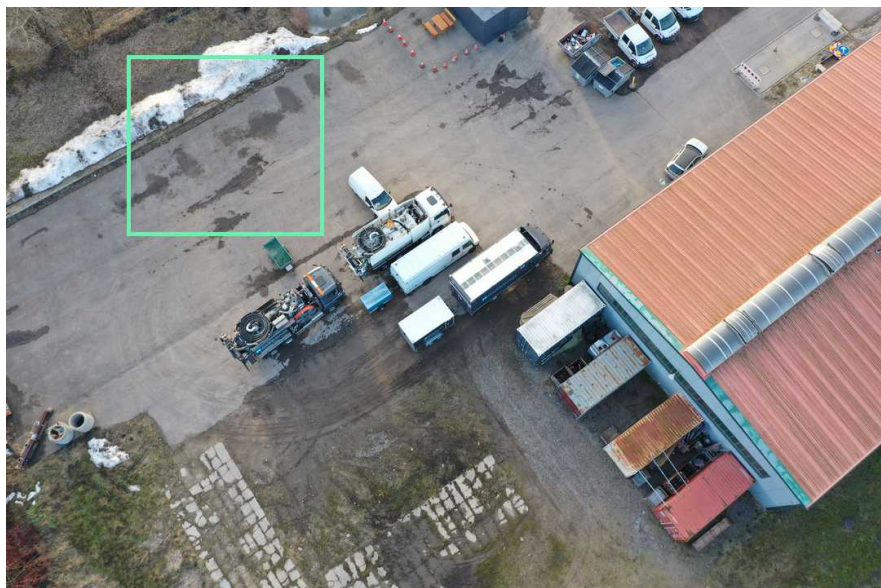
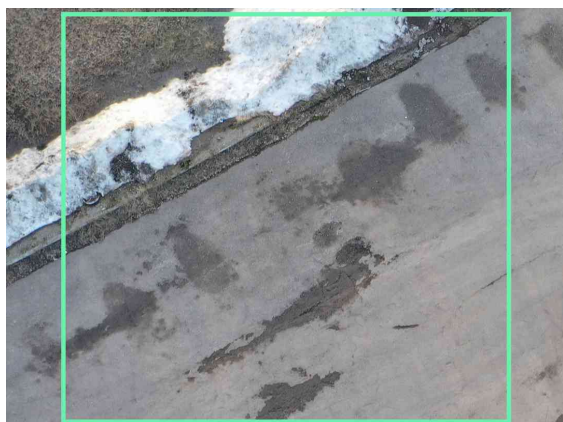
### **Annotation 10**

**Severity level:** 1

**Description:** Befestigte Fläche  
(Beton Asphalt)

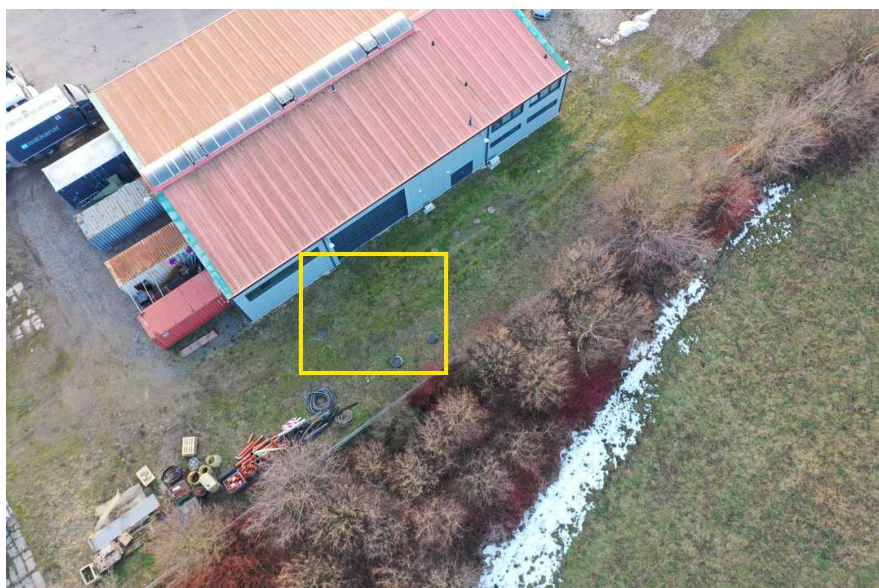
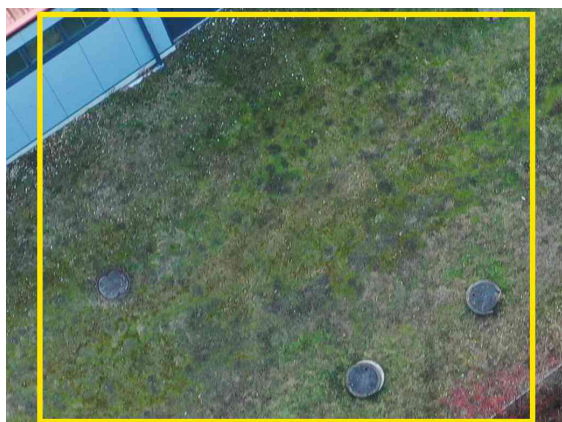
### **Annotation 8**

**Severity level:** 3

**Description:** Abscheider  
Waschhalle

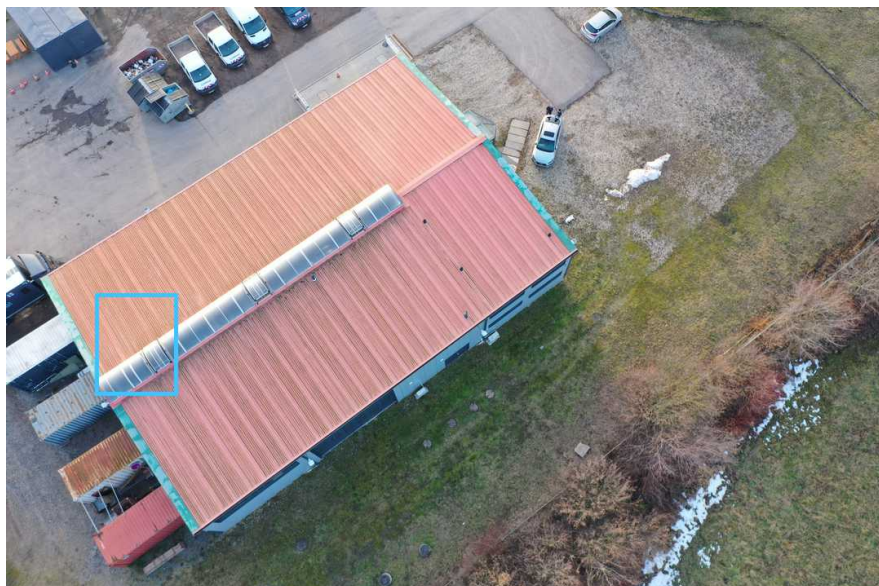
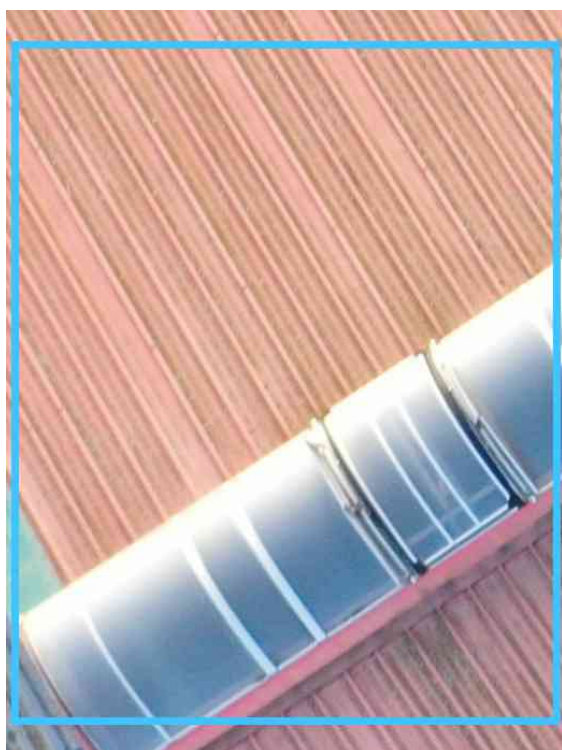
### **Annotation 9**

**Severity level:** 2

**Description:** Dachfenster  
elektrisch

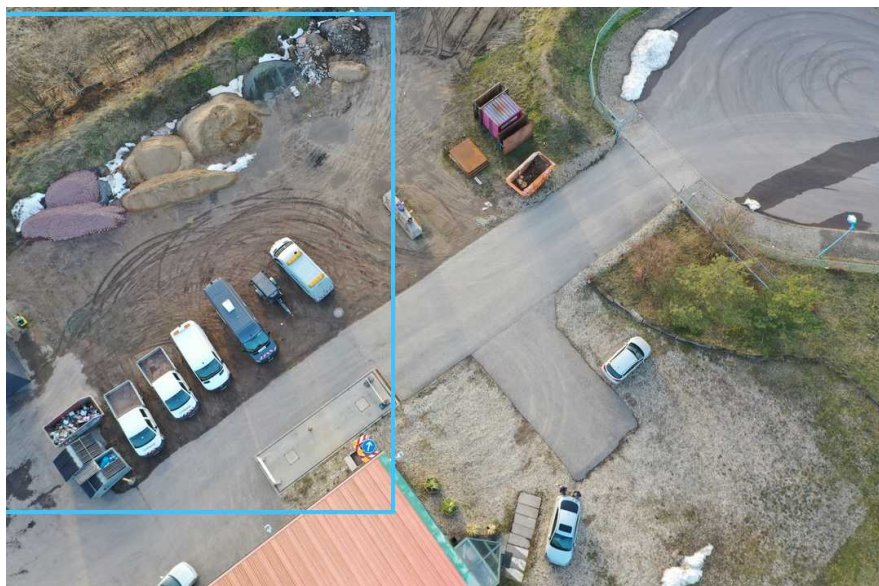
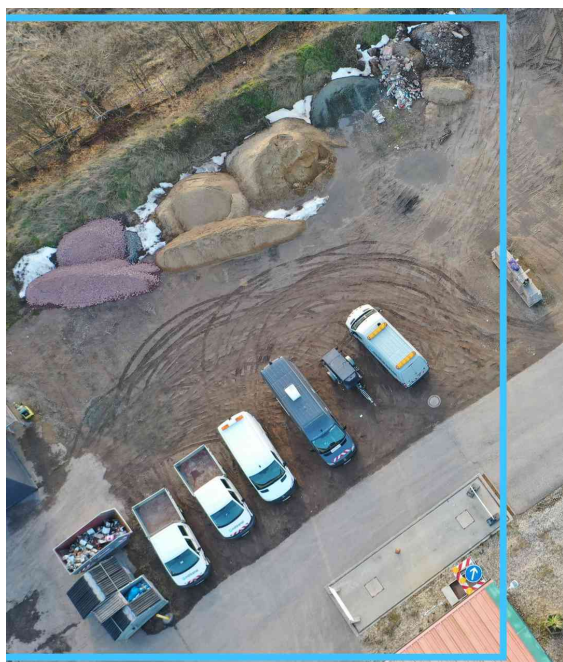
### **Annotation 12**

**Severity level:** 2

**Description:** Lagerfläche  
Schüttgüter/Parkplatz

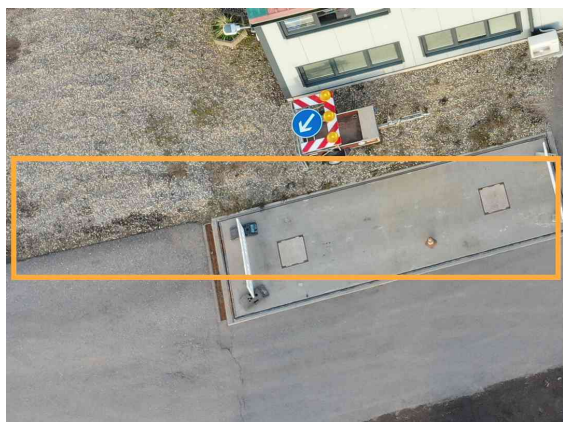
### **Annotation 7**

**Annotation type:** Spalling

**Severity level:** 4

**Description:** LKW Waage Beton  
Abplatzungen

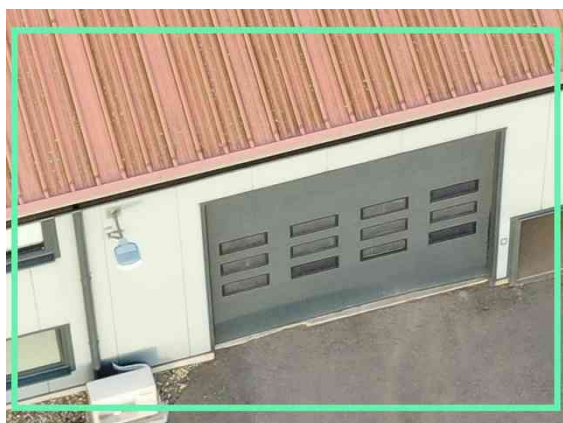
### **Annotation 3**

**Severity level:** 1

**Description:** Tor 1 Handbetätigt

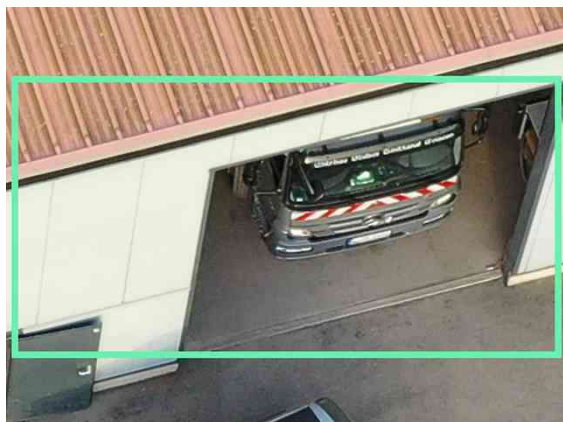
### Annotation 5

**Severity level:** 1

**Description:** Tor 2 Handbetätigt

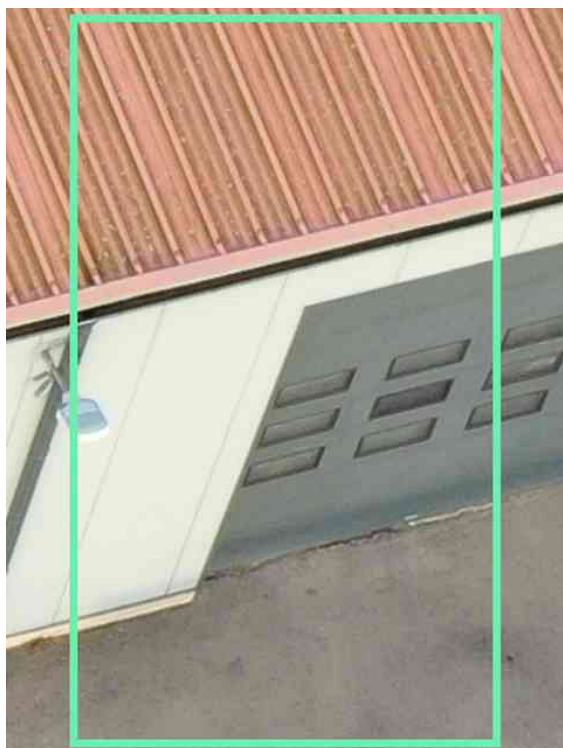
### Annotation 6

**Severity level:** 1

**Description:** Tor Waschhalle
