# Copter Service Leipzig

## Inspection Report

Asset: Gebäu-  
de 1

## Gebäude 1

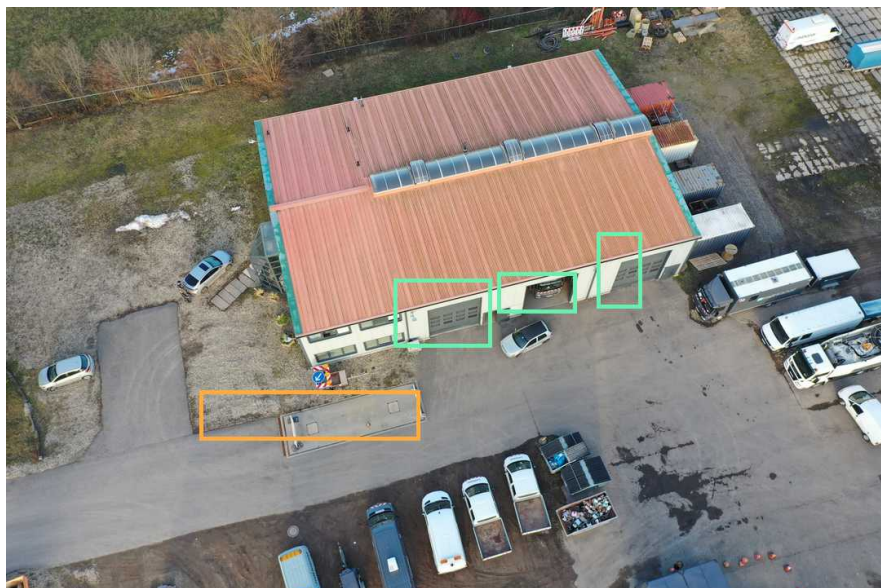
**DJI\_0371.JPG**

| ID | Annotation type | Severity | Description | Page |
|---|---|---|---|---|
| 7 | Spalling | 4 | LKW Waage Beton Abplatzungen | <a href="#">9</a> |

**Annotation type:** Spalling
